CSST ALERT

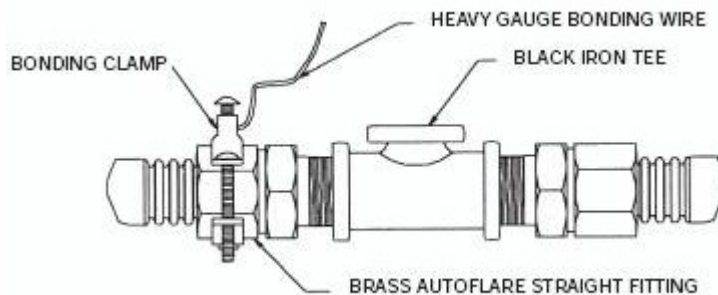
CSST is used to transmit gas in residential, commercial and industrial structures. CSST consists of a continuous, flexible, stainless steel pipe, and typically is covered with a yellow exterior plastic coating. CSST typically is routed beneath, through and alongside floor joists, inside interior wall cavities and on top of ceiling joists in attic space from a gas source to an appliance. Titeflex's CSST product is known as "GASTITE," Ward's CSST product is known as "WARDFLEX," OmegaFlex's CSST is known as "TRACPIPE" or "COUNTERSTRIKE," and Parker Hannifin's CSST product is known as "PARFLEX". Omegaflex's "COUNTERSTRIKE" CSST is covered with a black exterior coating with yellow lettering. CSST does not include gas-appliance connectors (*e.g.*, a connector that runs from a gas outlet to an appliance).

Typical CSST

DPS inspectors will inspect bonding of the CSST, if installed, per NEC (2002) Article 110.3 (B), its listing and manufactures' instructions. This will require, at a minimum that a (listed) bonding clamp be installed (on a fitting not the tubing), a bonding conductor (sized per table 250-66) be installed and connected to the Grounding Electrode System.
